RUST-X VCI Surface Protection Masking Tape

Scope

Trial Method

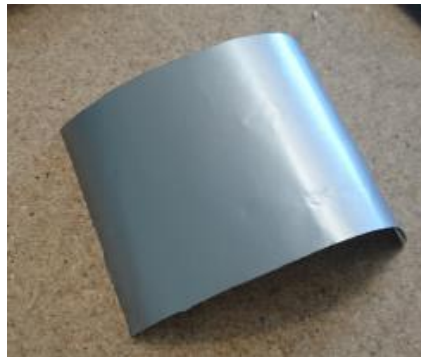
VCI Foil Square

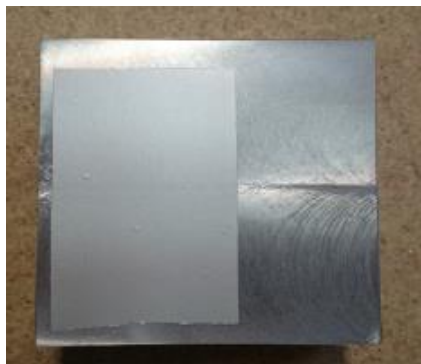
Stuck to billet

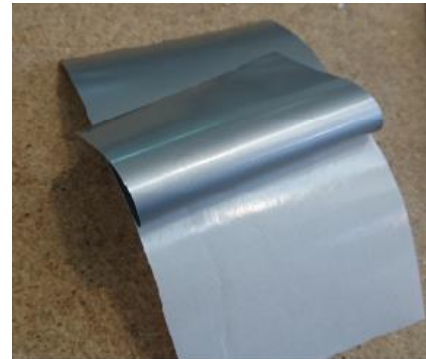
Backing removed

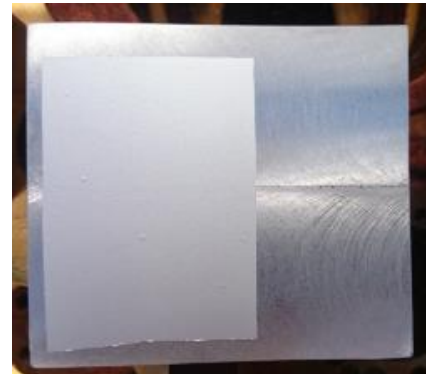
Billet placed outside

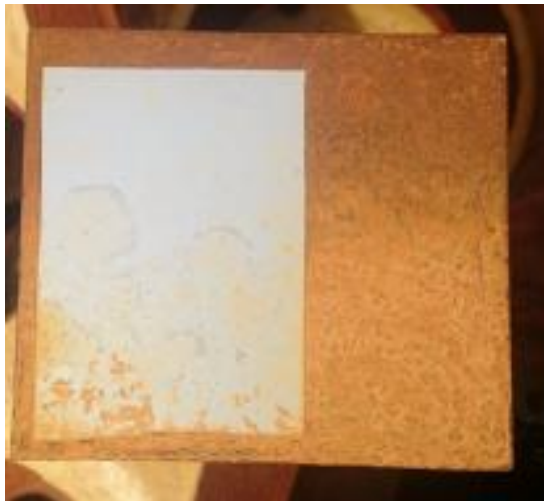
5 Jan 2015 – 3 Weeks

Billet shows signs of heavy corrosion.

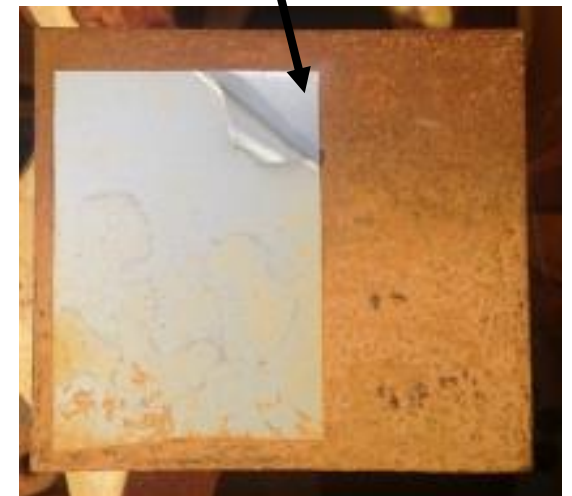
VCI Foil peeled back.

No corrosion under foil.

Foil re-stuck down.

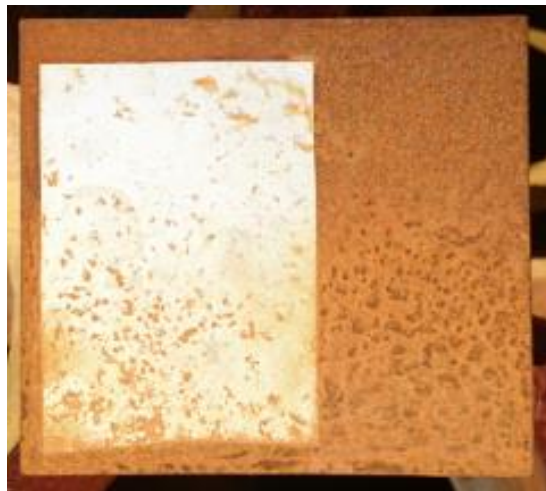
29 Jan 2015 – 6 Weeks

Billet shows
extensive surface
corrosion.

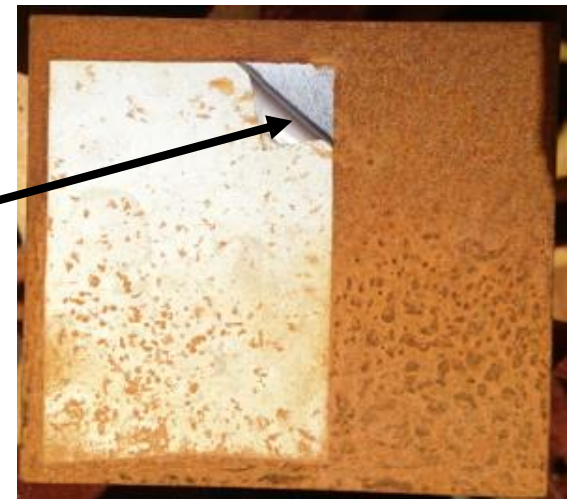
VCI Foil peeled back.

No corrosion under foil.

Foil re-stuck down.

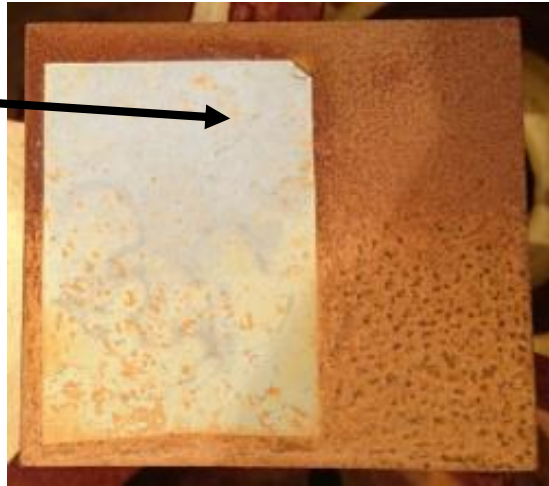
2 Mar 2015 – 11 Weeks

Billet shows
extensive surface
corrosion.

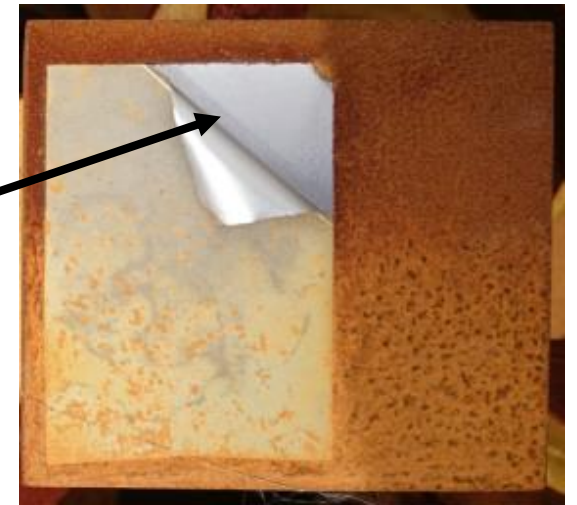
VCI Foil peeled back.

No corrosion under foil.

Foil re-stuck down.

Slight corrosion near
corner of foil.

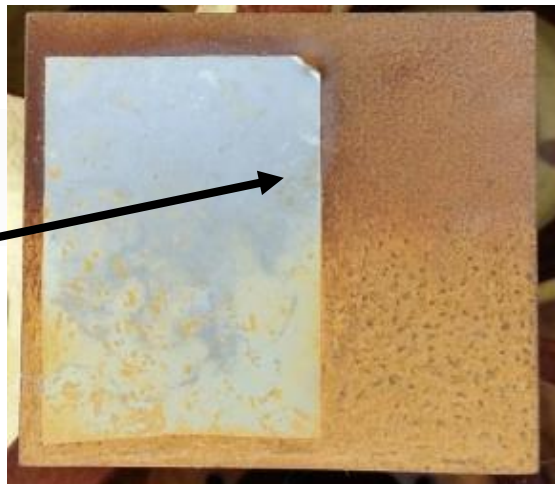
11 Mar 2015 – 12 Weeks

Billet shows
extensive surface
corrosion.

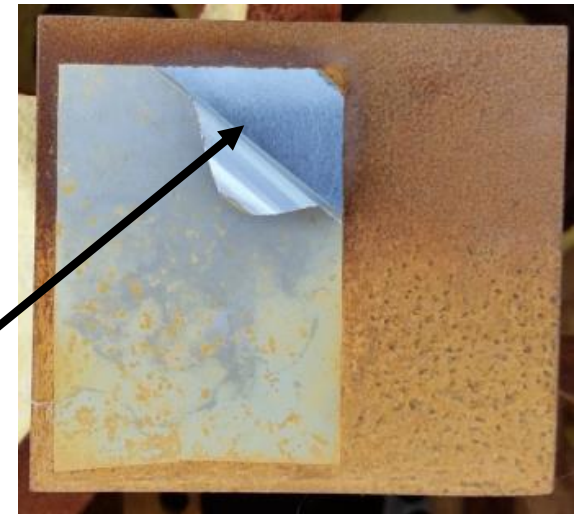
VCI Foil peeled back.
No corrosion under foil.
Foil re-stuck down.
Slight corrosion near
corner of foil.

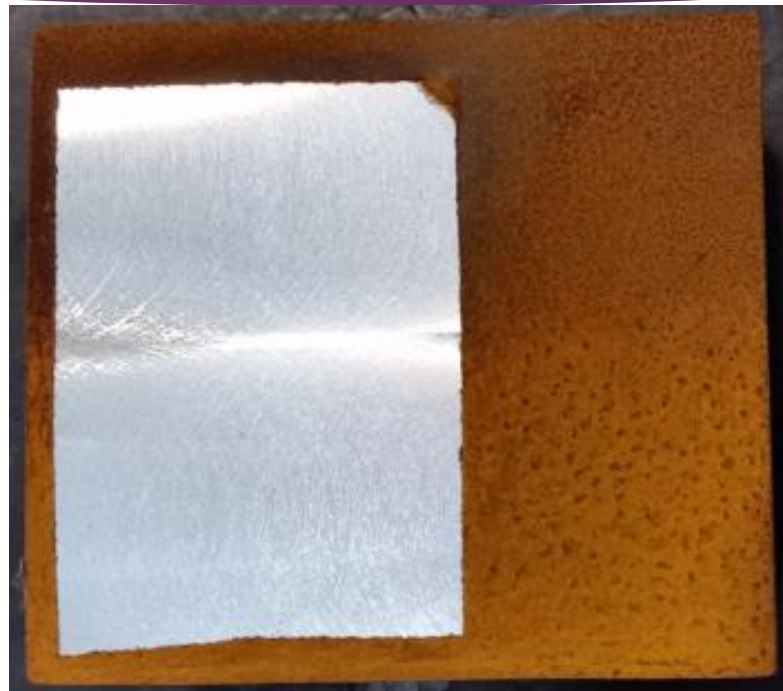
11 Mar 2015 – 12 Weeks Removal of Foil

Foil removed
completely.

Protected surface is
clean and unchanged
from original surface.

Machining marks can
still be seen on the
protected surface.

Area under the FOIL

100% as original
without any signs of
RUST after 3 Months
of Exposure to
Rainfall, Sea
humidity etc.

- ▶ Rust-X VCI Foil has effectively protected the billet surface from corrosion.
- ▶ The protected surface appears in as good a condition as it was at the beginning of the trial.
- ▶ The general “re-stickability” of the foil appears to be very good and still able to re-stick after being pulled back 4 times in 12 weeks.
- ▶ The VCI foil was still in good condition after 12 weeks with a slight loss of adhesiveness at the corner due to being in contact with fingers as it was pulled back multiple times.
- ▶ The removed foil could be re-applied to the surface with very good re-adherence.

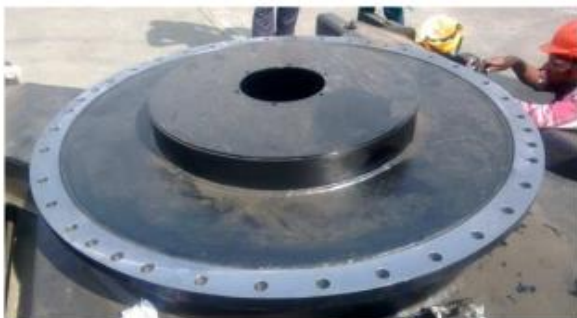
Before

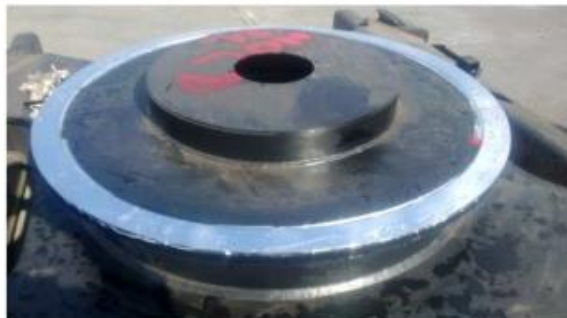
After

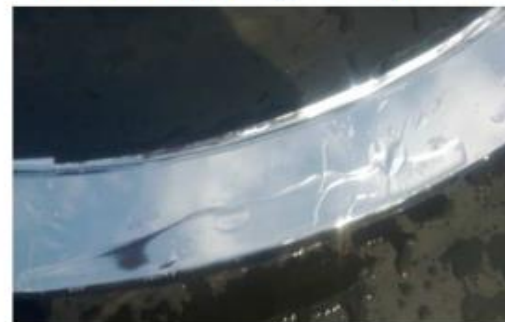
Closer look @ ring

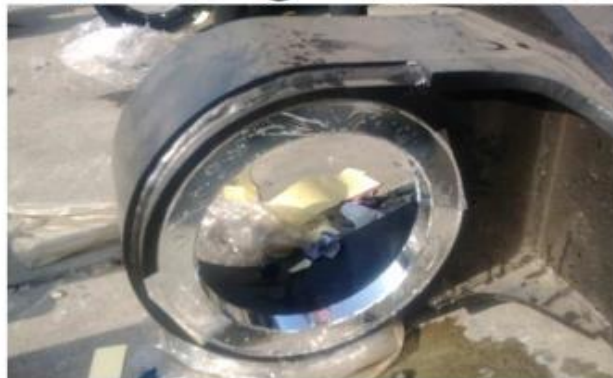
Closer look @ motor bracket
